Mobile Intel® Celeron® Processor on .13 Micron Process in Micro-FCPGA Package

Specification Update

May 2004

Revision 020

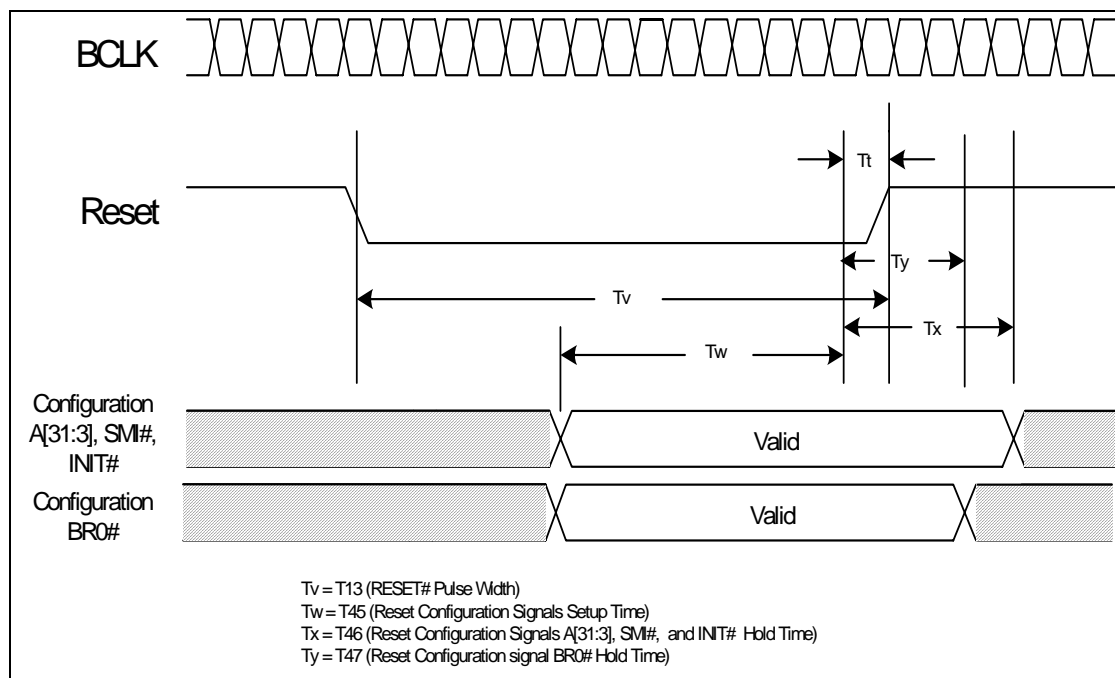
Figure 12. System Bus Reset and Configuration Timings

The BR0# maximum hold time has changed to 2 BCLKs. This change will be shown in the “System Bus AC Specifications (Reset Conditions)” table and “System Bus Reset and Configuration Timings” figure of the *Mobile Intel® Celeron® Processor on .13 Micron Process in Micro-FCPGA Package Datasheet*. This change will be incorporated in the next revision of the datasheet.
